Ohio Field Buildings

Herrick Archives Number H 239

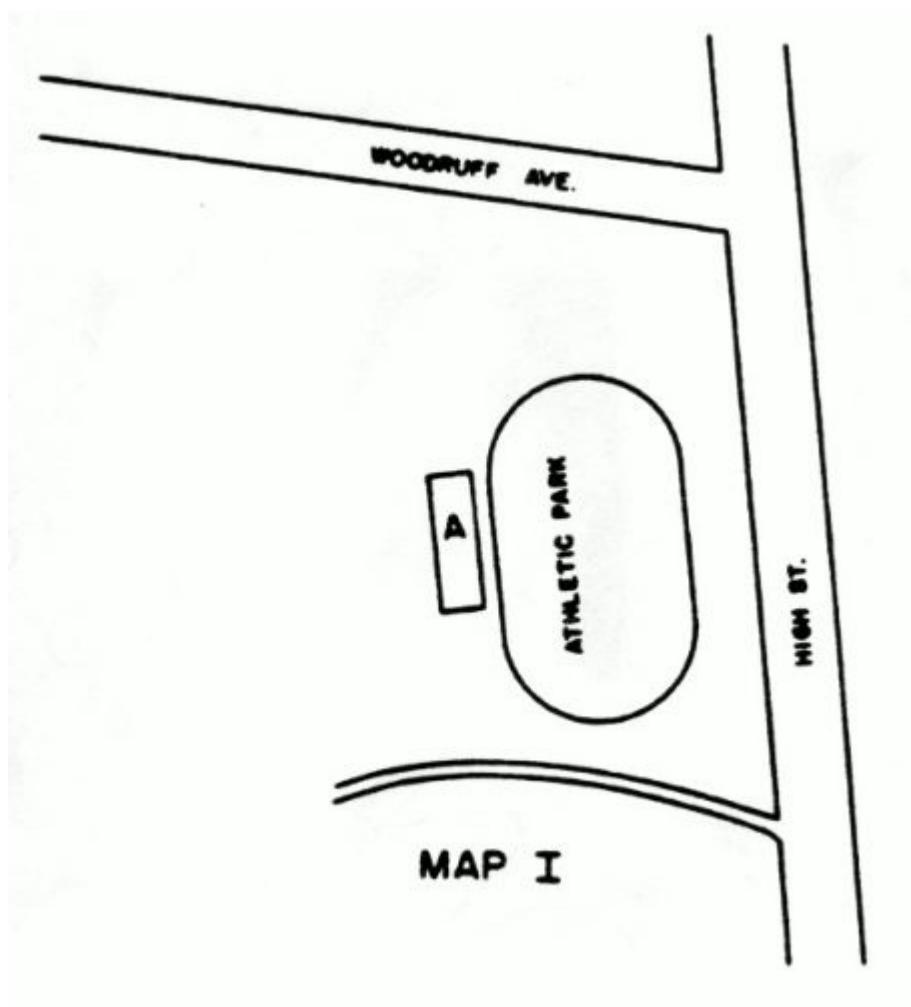
Map I — This is based on Map 190-01, which was reconstructed from memory by Professor Bradford to depict the campus in 1900. It cannot be regarded as highly accurate as to details.

Map I shows the location, as recalled later by Professor Bradford. The exact location has not been established.

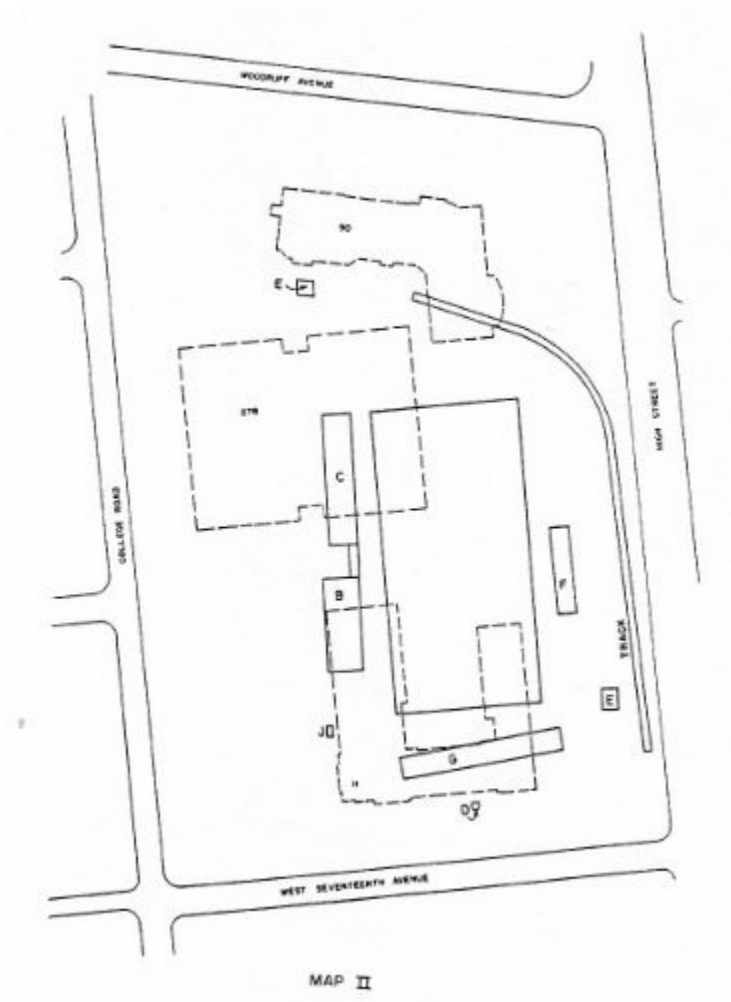
Map II— This is a 1906 map (790-09), which was prepared by a surveyor, and presumably is accurate. The map has been modified to show present buildings and present surrounding streets.

For Identification of buildings shown by broken lines, see Appendix A.

The Lantern on September 20, 1901 reported that the bleachers were over 100 feet long. Map II shows a connection between Structures B and C, which has not been identified. Typical photographs of these west bleachers are X 1984, X 1988 and X 1989. These bleachers were replaced in 1910 by new bleachers (Structure H).

Map II shows unidentified structures at the northwest and southeast (not northeast) corners of the field. It is possible that these were the team shelters. No photographs of these shelters have been found.

The Lantern on December 11, 1901 reported that temporary bleachers were erected on the east side of the field, and were removed at the end of the season. It is probable that they were re-erected from time to time until permanent bleachers (Structure K) were erected. See Map II, which shows bleachers on the east side of the field.

The only information found with respect to this structure is that it is shown on Map II (1906). No photograph has been found.

This appears only on Map II and is not identified. No photograph has been found.

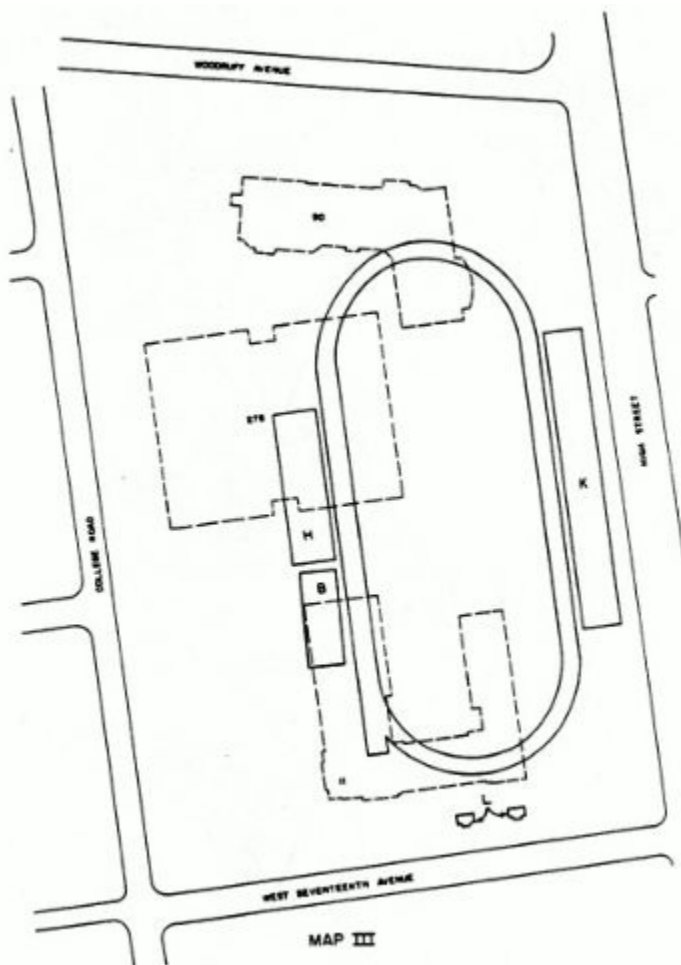
Map III — This is Map 191-14, which was prepared and kept up to date by the University Architect from 1912 until the middle or late 1920's. Again, present buildings and surrounding streets have been added.

For identification of buildings shown by broken lines, see Appendix A.

The Lantern on September 21, 1910 reported that the new bleachers on the west side would be ready in two weeks. These replaced Structure C, were larger, and were set at a slightly different angle. Compare Maps II and III in this regard.

The two ticket offices shown at the south end of the field on Map III were erected during the summer of 1909 (L September 21, 1909).
